National Dam Safety Program.
Echo Lake Intake Dam. (NJ-008167).
Echo Lake Spill Way Dam. (NJ-00558)
Passaic River Basin Macopin River.
Passaic County, New Jersey.
Phase I Inspection Report.

ECHO LAKE INTAKE DAM ECHO LAKE SPILL WAY DAM

PHASE I INSPECTION REPORT

NATIONAL DAM SAFETY PROGRAM

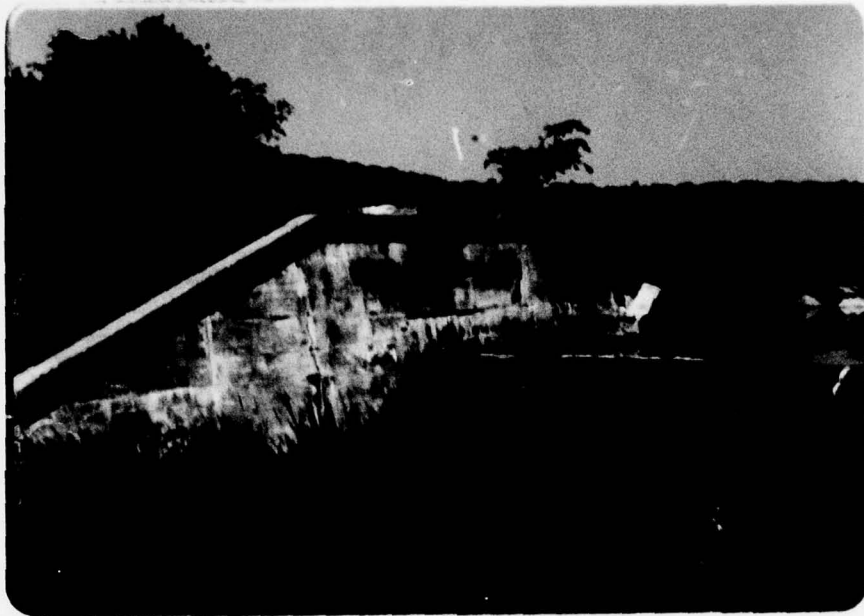
The concrete spillway is in serviceable condition. However, the side walls are broken at the upstream toe due to earth and riprap thrust. As a consequence, the rip-rap in this area has suffered local slides. A minor seepage has been observed at the toe of the right abutment side wall.

Right side-wall of
spillway.

1. The Echo Lake Spillway sidewalls must be repaired. The first priority is to rebuild the side walls of the spillway by making them stronger and anchored them into rock. At the same time the rip-rap should be repaired. This should be done very soon.
2. A device for collecting floating debris should be installed as soon as possible upstream of the spillway. It should be assumed that floating debris will include row boats and newly uprooted trees. The large rock at the upstream side of the culvert below the road should be removed. This should be done soon.
3. The wing walls of the outlet culvert at the Intake Dam should be repaired. This should be done very soon.

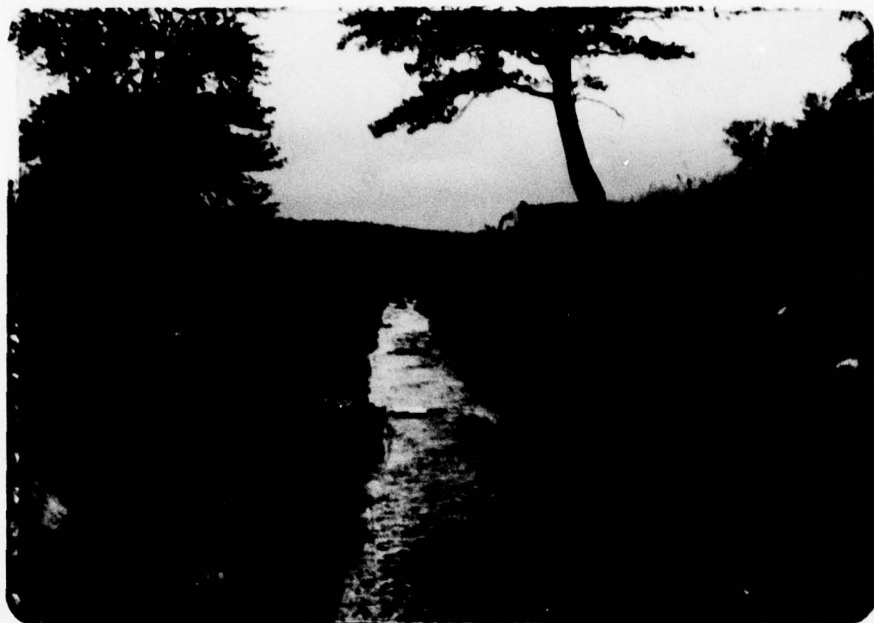
The embankment does not show signs of movement and is in good condition. Minor sloughing of the rip-rap has occurred in the spillway discharge channel. The culvert of the discharge channel of the spillway below the road is partially obstructed with a boulder. It is reported that this underpass has been partially obstructed by driftwoods during the 1903 flood. This occurred prior to construction of the present dam.

Spillway discharge canal
looking upstream.

(1) Repair the stone rip-rap on the spillway dam's approach and discharge channels. At the same time remove the brush from the discharge channel.

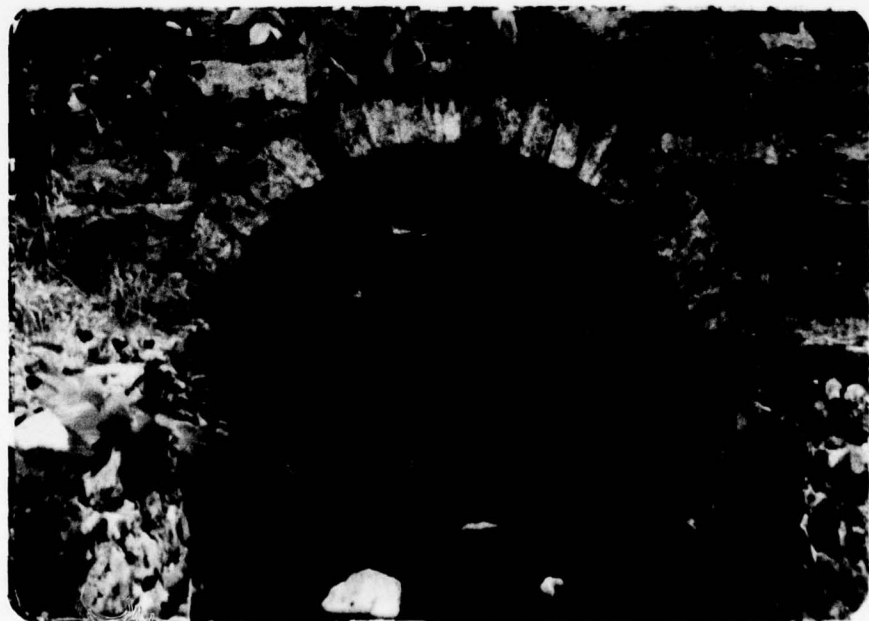
Culverts below road and Route 23
along spillway discharge canal looking
downstream. Note boulder at end of culvert
below road.

It should be assumed that floating debris will include row boats and newly uprooted trees. The large rock at the downstream end of the culvert below the road should be removed. The wing walls of the outlet culvert should also be repaired. The control valves at the dam spillway and trash rack structures are in well maintained operating condition. However, the valves at the intake tower should be brought up to an operational efficiency that requires only one man to operate this station. An underwater inspection should be made to determine if debris or buildup in the gate tracks is binding and inhibiting operation, and the gate tracks cleaned and lubricated. The stem guides should have bronze bushings installed and the stems should be lubricated. Should the above allow for one man valve operation then this is all that should be done to these occasionally used valves. We estimate the dam can adequately handle the PMF and there will be approximately 1 ft of freeboard remaining.

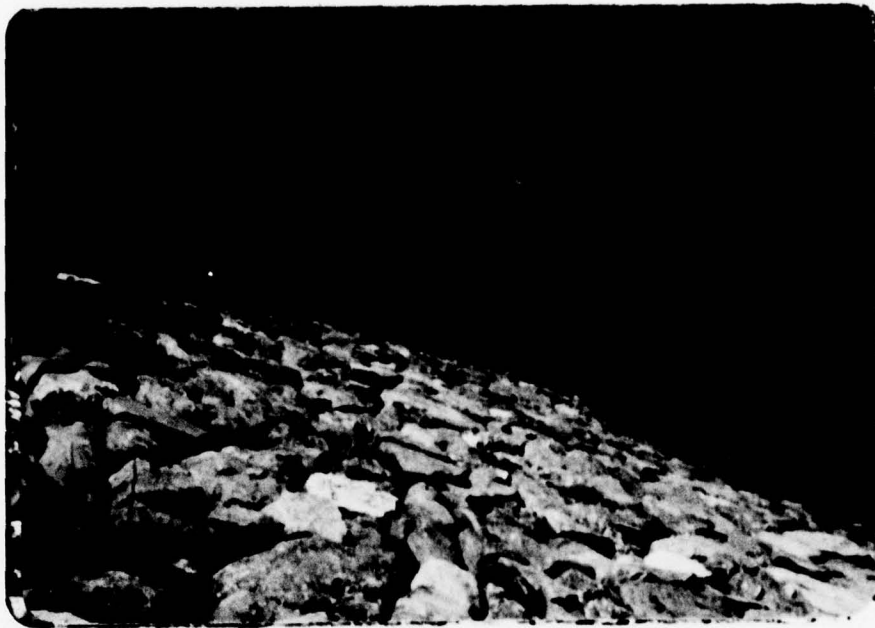
Upstream riprap at right
embankment looking west from
spillway.

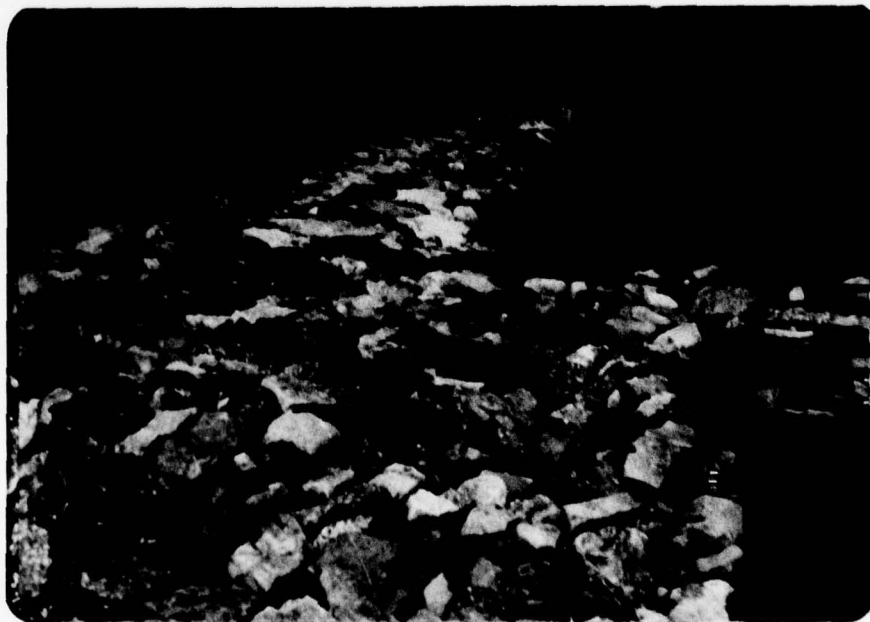
Upstream rip rap at right
embankment. Looking west from
intake structure.

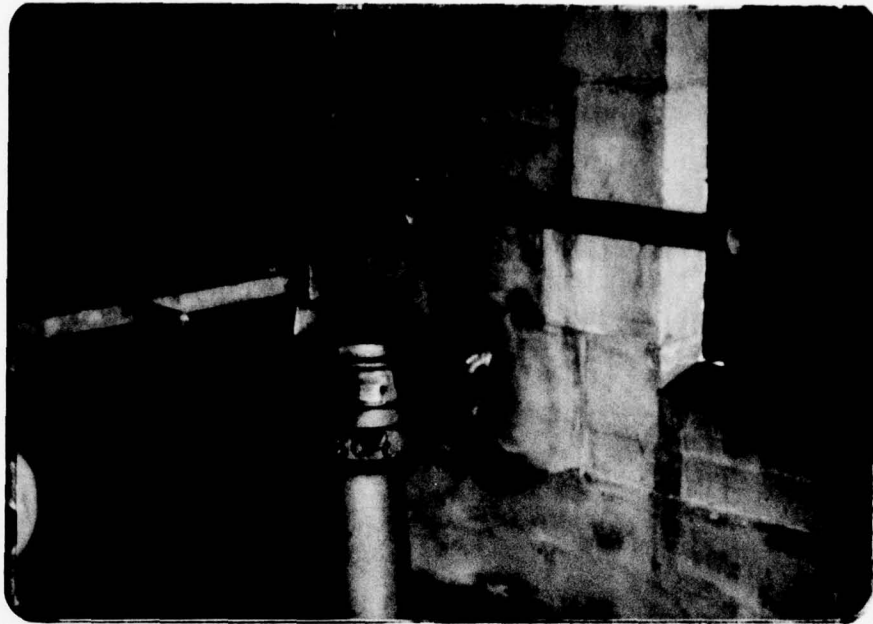
One of three Rodney Hunt manually 20 June 1978
operated control valves at intake structure.

(7) Make an underwater inspection to determine the cause of inhibited gate operation. Clean, lubricate, and repair the gates and gate tracks as necessary.

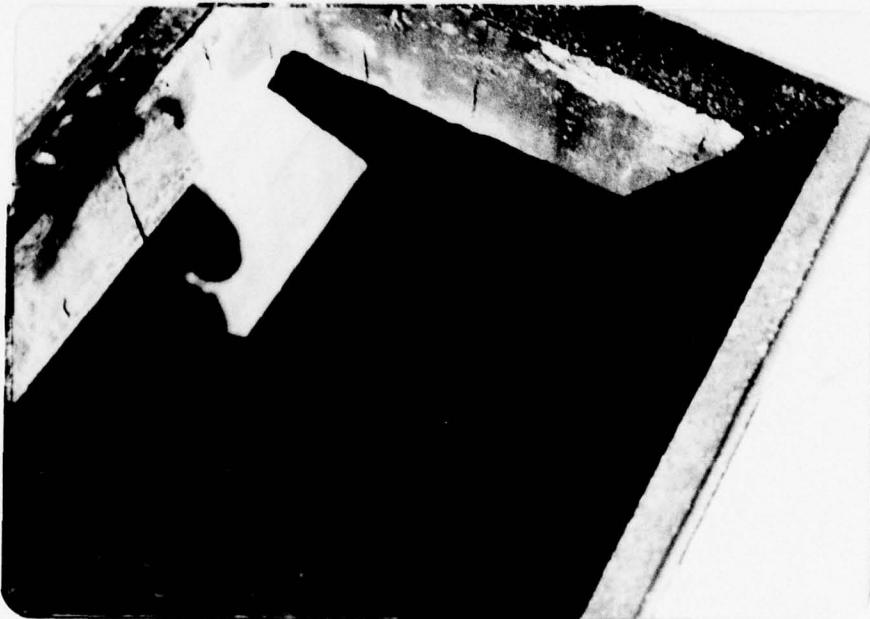
Control valve at right side 20 June 1978
of spillway.

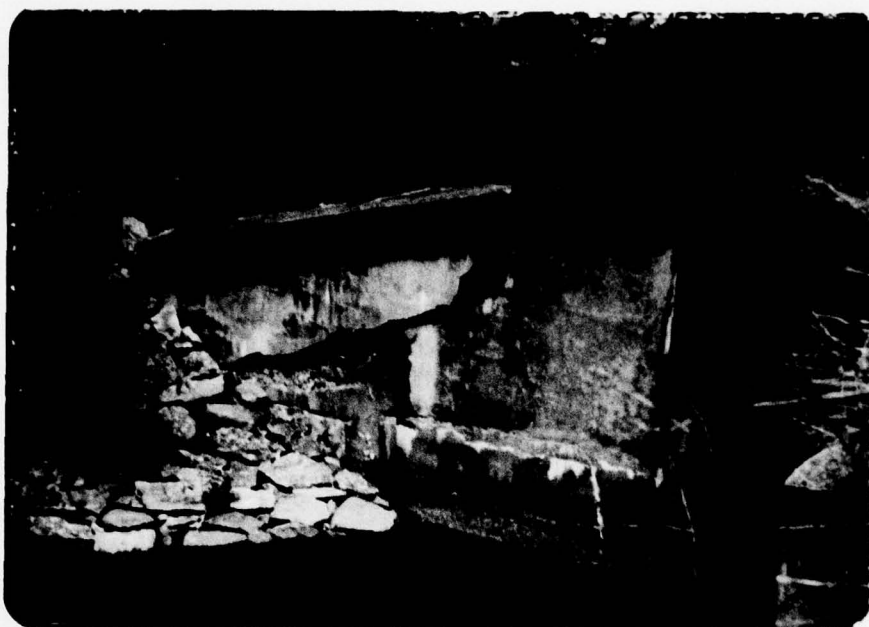
Some trace of moisture appears at a construction joint on the left side of the intake discharge culvert about two feet above downstream water level. Minor seepage was observed outside the culvert along the left wall. The downstream wing walls of the culvert have failed.

Right wing wall of intake
structure discharge tunnel.

(5) Repair the deteriorated concrete wingwalls of the outlet conduit for the intake dam.
